LPC# 0430305282--DuPage County  
Downers Grove/Ellsworth Industrial Park  
ILN 000508246  
SF/HRS

# CERCLA

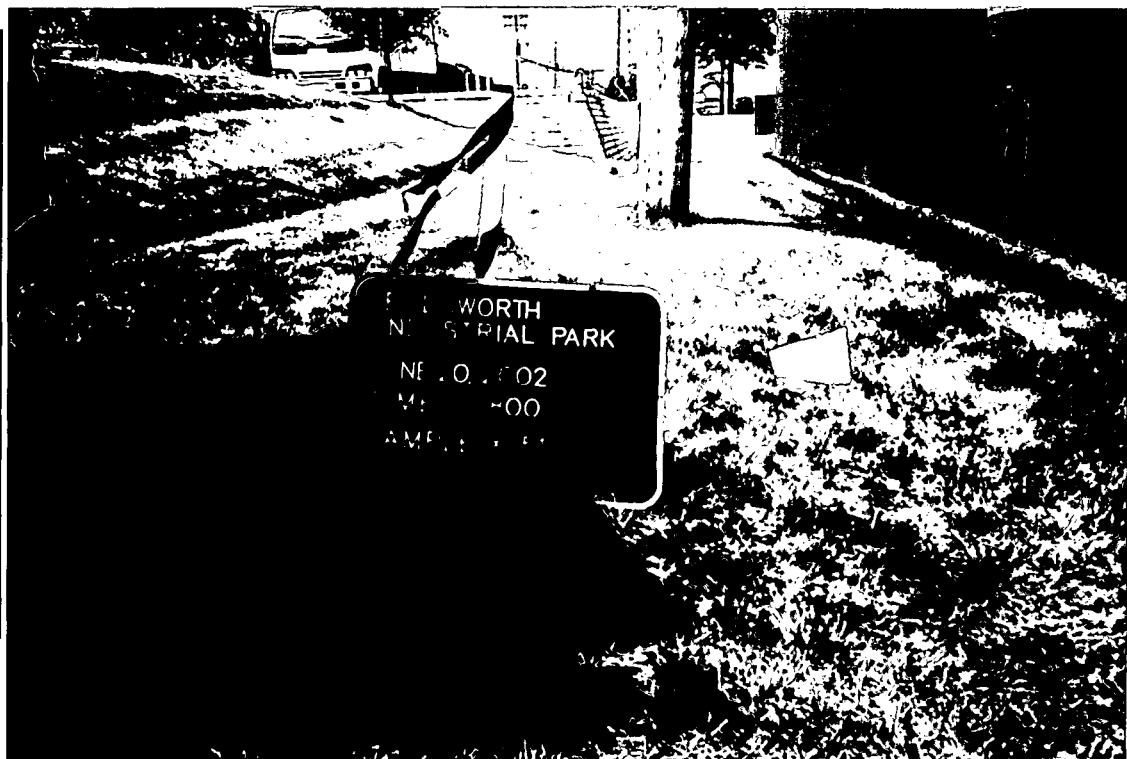
**COMMENTS:** Photo of soil sample location X-51, collected from probe location GP-51. Location is south of the Fusibond facility off of Katrine Avenue.

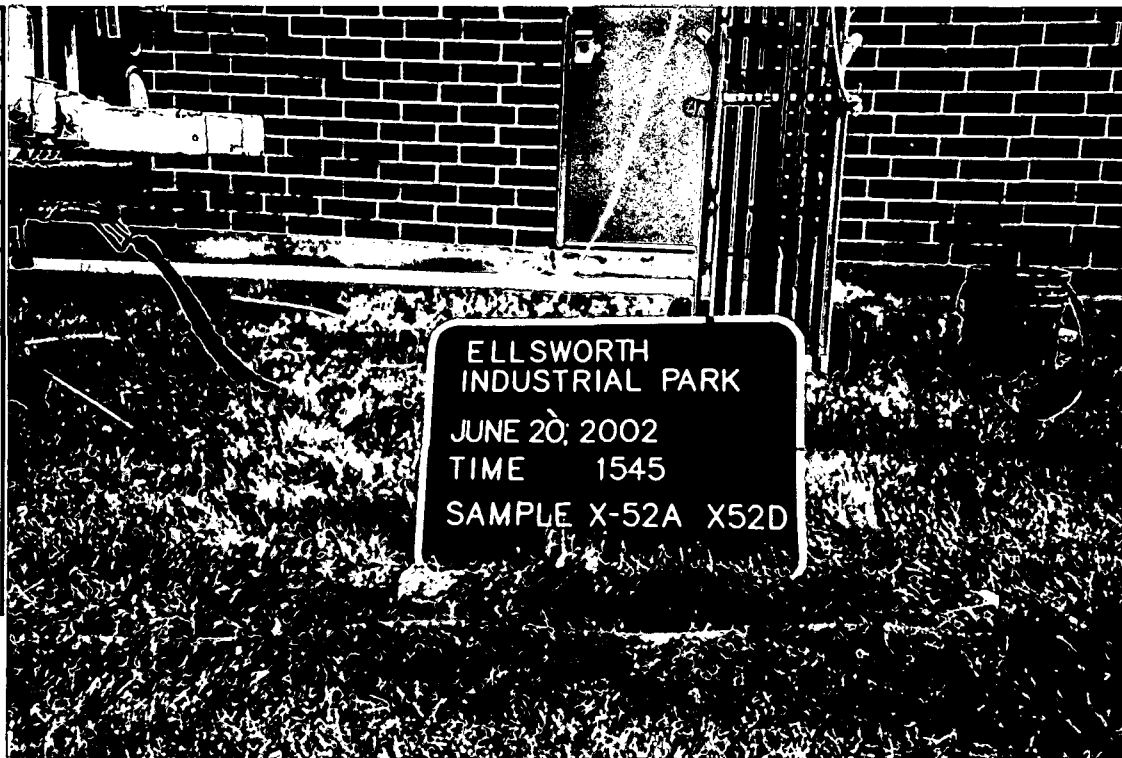
**COMMENTS:** Photo of soil sample location X-52A and X-52D, collected from probe location GP-52. Located north of the Tricon Industries, Inc. facility at 2325 Wisconsin Street.

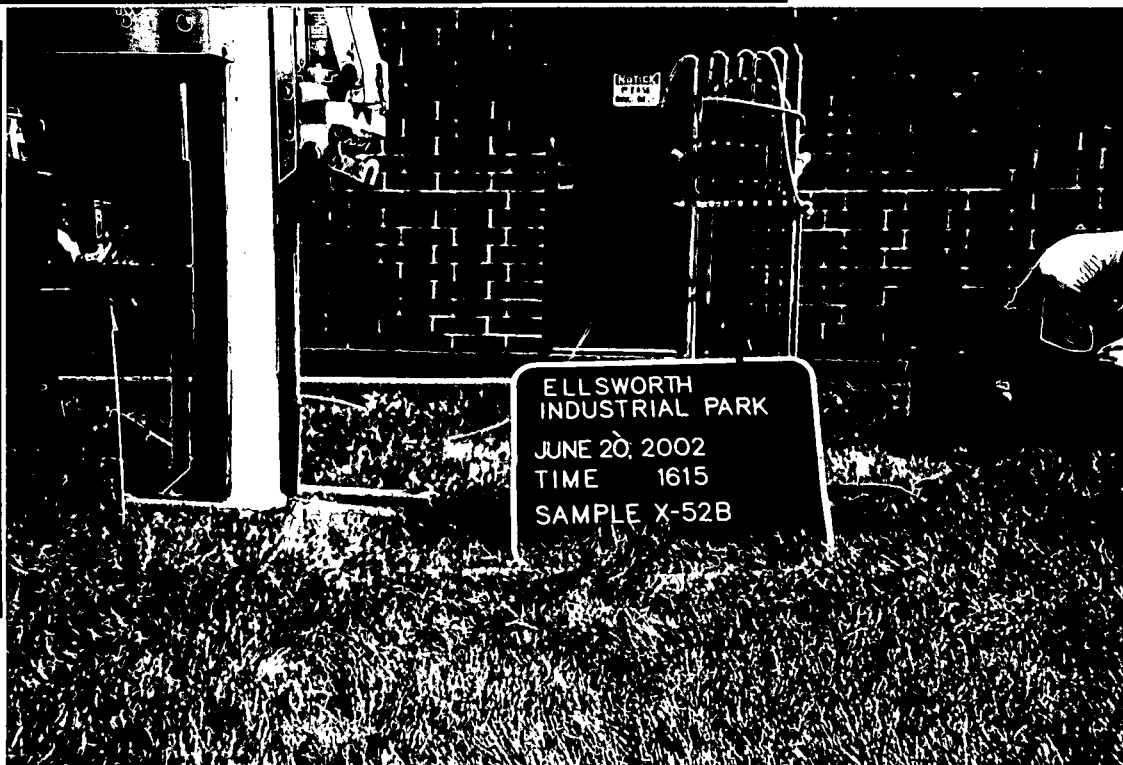
**COMMENTS:** Photo of soil sample location X-52B, collected from probe location GP-52. Located north of the Tricon Industries, Inc. facility at 2325 Wisconsin Street.

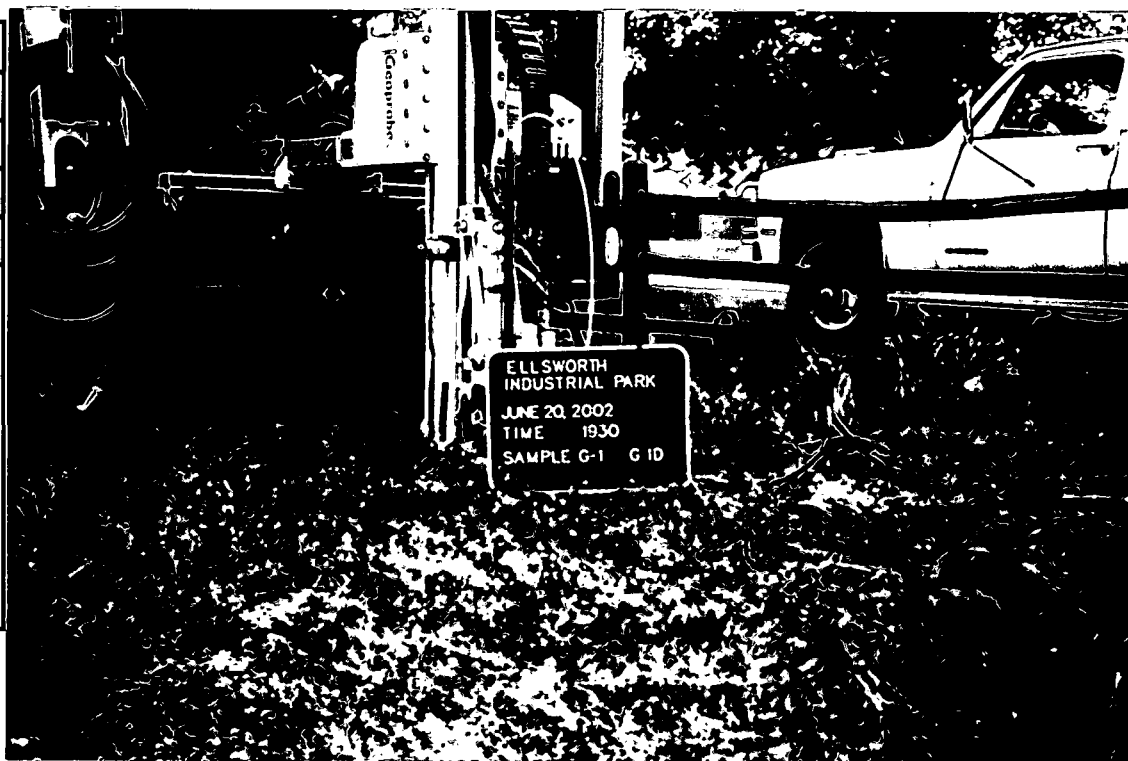
**COMMENTS:** Photo of groundwater sample location G-1, collected from probe location GP-1. Located on Arrow Gear Co. property north of St. Joseph Creek, in former parking area.

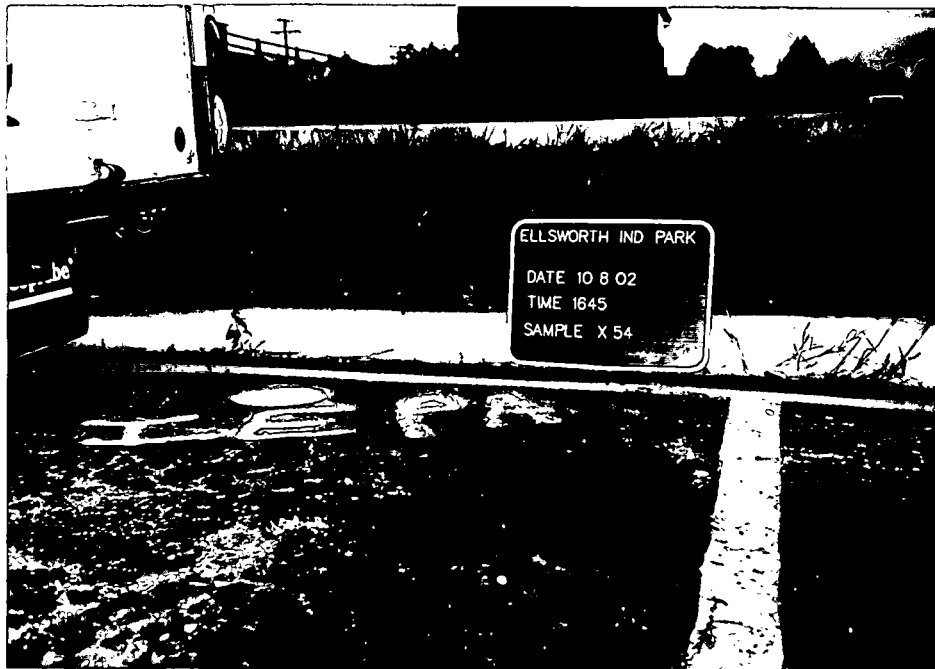
**COMMENTS:** Photo of soil sample location X-54, collected from probe location GP-54. Located at the western edge of the former Morey Corporation facilities parking lot.

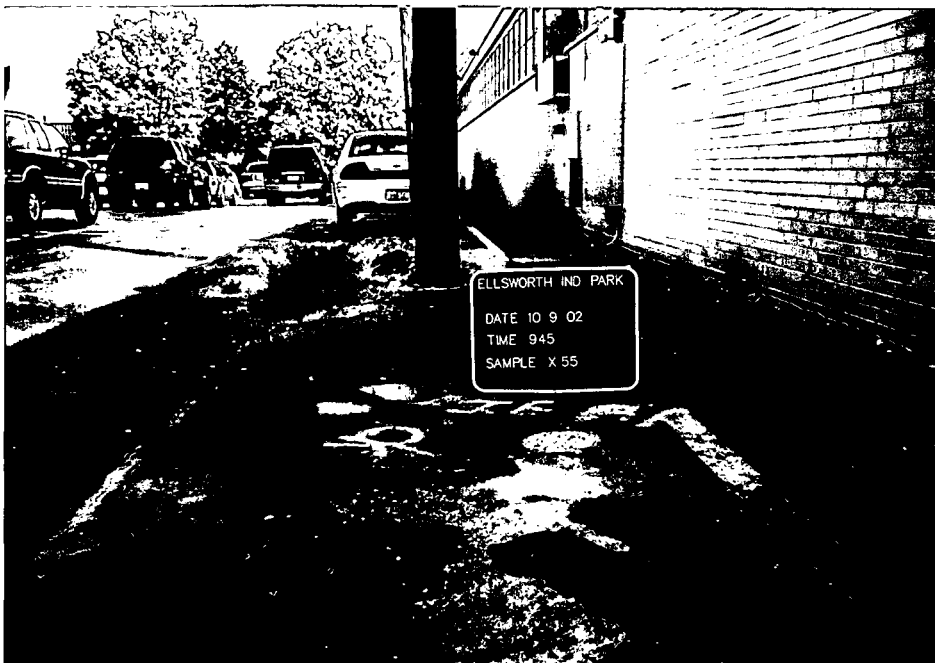
**COMMENTS:** Photo of soil sample location X-55, collected from probe location GP-55. Located at the west edge of the former Morey Corporation facility.

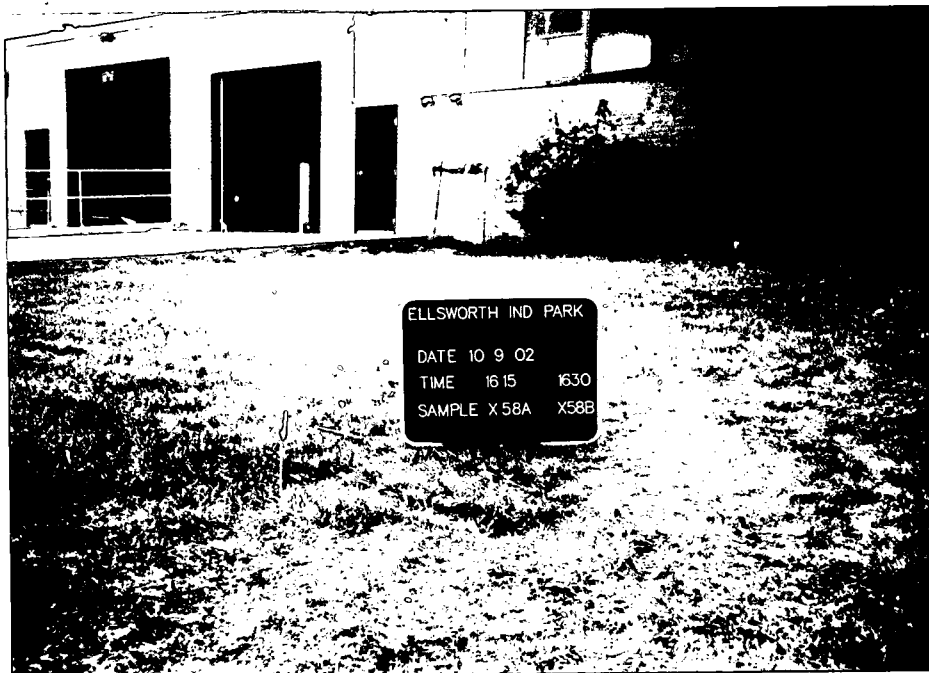
**COMMENTS:** Photo of soil sample location X-58A and X-58B, collected from probe location GP-58. Located on the east side of the former Morey Corporation facility.

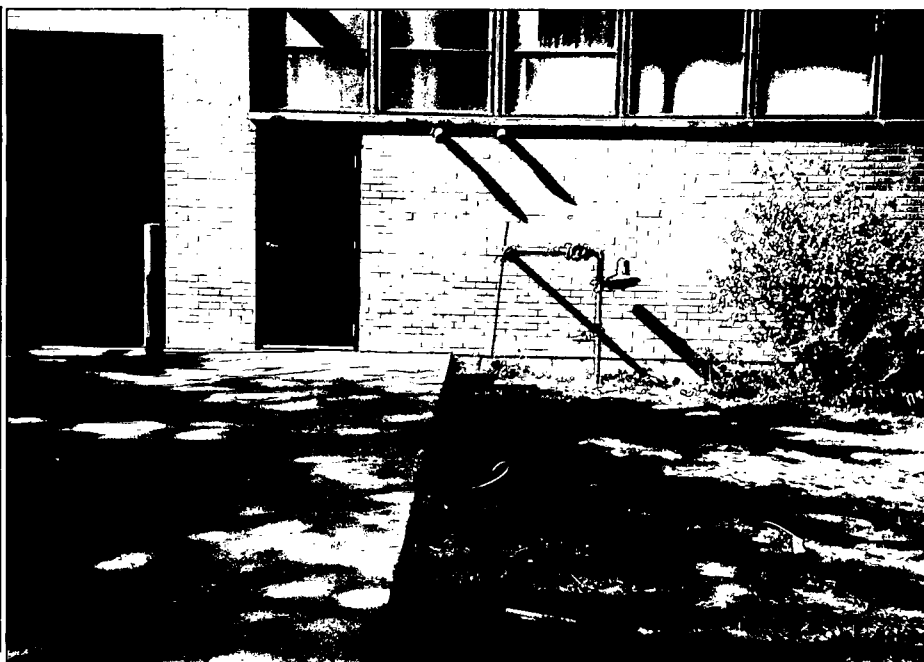
**COMMENTS:** Photo of soil sample locations X-59A and X-59B, collected from probe location GP-59. Location is east of the former Morey Corporation facility, near the loading dock area.

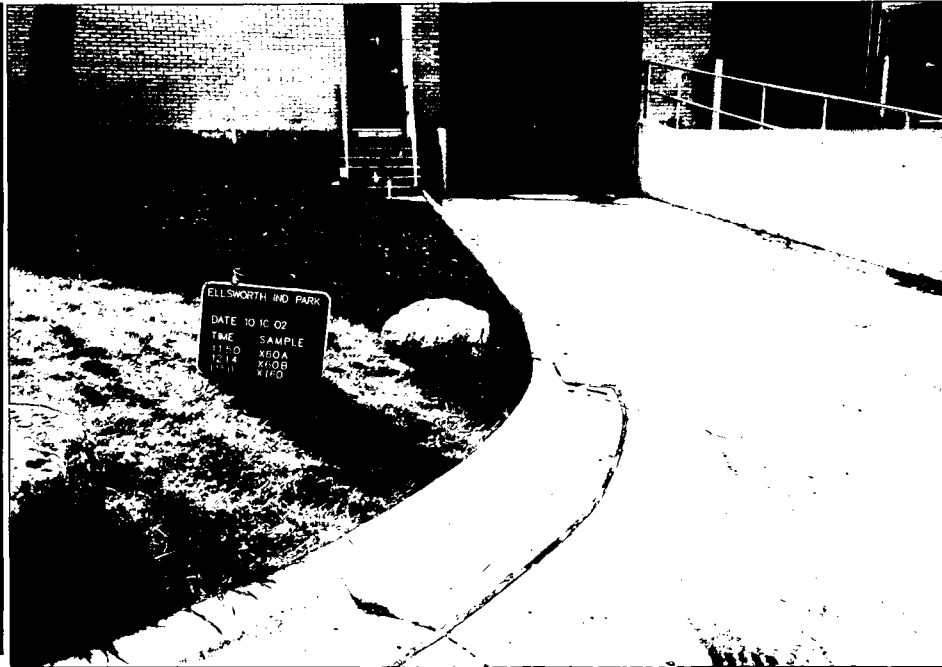
**COMMENTS:** Photo of soil sample location X-60A and X-60B, collected from probe location GP-60. Location is east of the former Morey Corporation facility near the loading dock area.

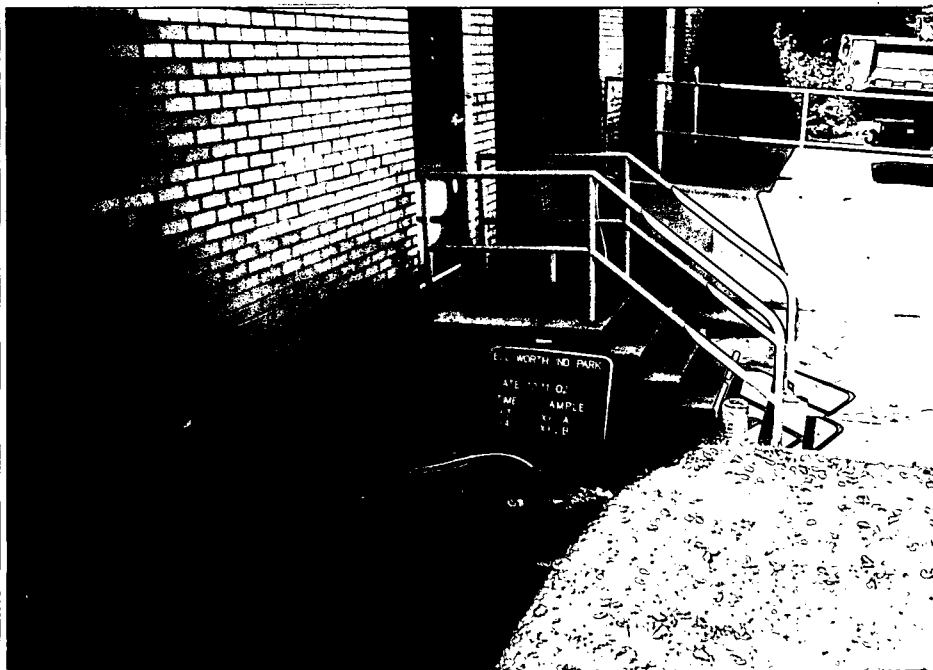
**COMMENTS:** Photo of soil sample location X-62A and X-62B, collected from probe location GP-62.

Located near building and loading dock east of the former Morey Corporation facility where floor drain exited building.
